PUMP REPAIR TRANSFORMATIONS

KSB AMACAN PUMP BEFORE

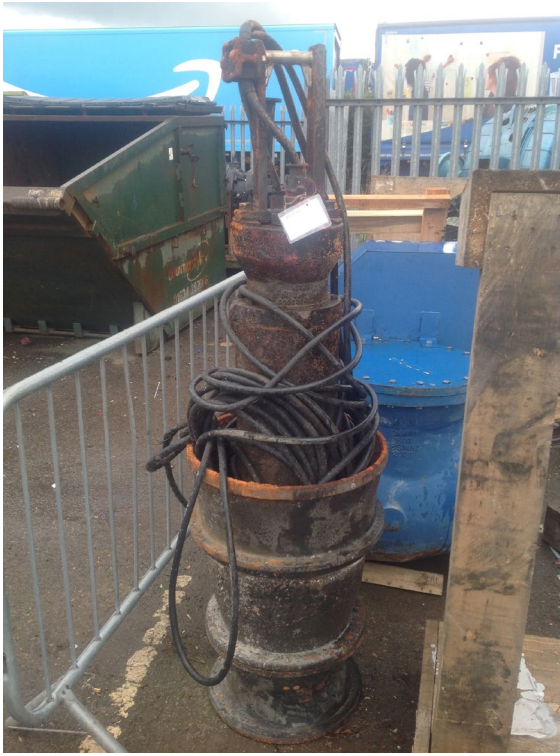
- This KSBAMACAN pump was removed using a contract lift and brought back to the workshop using a lorry.
- The pump's suction side was full of foreign body, it was then stripped and inspected. Foreign body was found wrapped around the lower mechanical seal and the outer seal casing O ring.
- The power cables were damaged and needed to be replaced.
- Water ingress into stator winding, which was chemically cleaned and placed in the stoving oven.
- On the following day, the winding was electrically tested, Baker tested and passed.

A basic repair kit was fitted, comprising of the following:

- Drive and non drive end bearings
 - Mechanical seal set
 - Full O ring kit
 - 2 x terminal boards
 - 1 x bearing housing
 - 1 x outer seal casing O ring
 - 1 x 20M power cable
 - 1 x 20M tele cable
-
- Machine and sleeve mechanical seals stationary seat.
 - Machine and sleeve the pump shaft due to the mechanical seal area being undersize.
 - The pump shaft was straightened as it was slightly bent.
 - The impeller and motor was balanced to G6.3 or better with the power cables replaced.
 - The pump seal chamber pressure was tested and we filled the mechanical seal chamber with oil.
 - The pump went through a test run in the test bay, and was then cleaned and painted to a standard shade, ready to be returned to the customer.
